METHODS AND RESULTS OF NATURAL INSPECTIONS OF BYELORUSSIAN WATER OBJECTS AS SOURCES OF TECHNOGENIC CHARACTER EMERGENCY SITUATIONS.

Methodology and results of Belarus artificial water bodies' field surveys were presented. Based on these results potential risk coefficient for hydrodynamic accidents possibility estimation was counted. Belarus water bodies were classified as potential sources of natural emergencies.

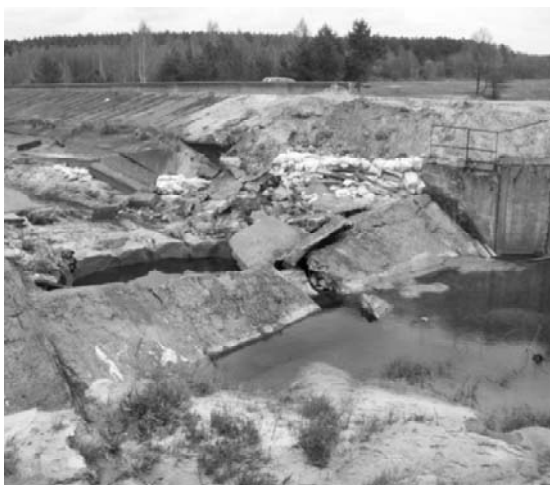
Consequences of НЕСТARE on the Mlynoksk reservoir (inspection 4/29/2010):
a – view of left-bank part of the dam; *b* – view of the spillway from the upper pool

The data provided in Table 2 states that the greatest danger is represented by the water waste constructions the technical condition of which will not allow to pass high waters of high security(flooding) in time and can lead to a water modulation through the dam crest. According to the factor of K_3 Mlynoksk and Chigirinsk reservoirs were considered to belong to extremely dangerous class.

Natural inspection materials on HECTARE consequences on the Mlynovsk reservoir are given in the pictures *a* and *b*.
